Using Security Camera Video in Accident Reconstruction

Detective Tilo Voitell, Denver Police Department, Traffic Investigations

Abstract: In November of 2006 a family with small children was crossing the street in downtown Denver when they were hit by a DUI driver that fled the scene. A license plate that was left behind led to the arrest of the driver and passenger a few hours after the collision. There were contrasting witness statements about what happened due to the traumatic nature of the event. Several video cameras in the area captured the event. The video recordings from those cameras were used in conjunction with a scale diagram and traffic engineering report to clarify the actual sequence of events as well as determining the vehicle's speed. The author was involved in this investigation and discusses the methodology behind the speed determination as well as how he was able to determine the driver had a red light when the light was not visible in the video.

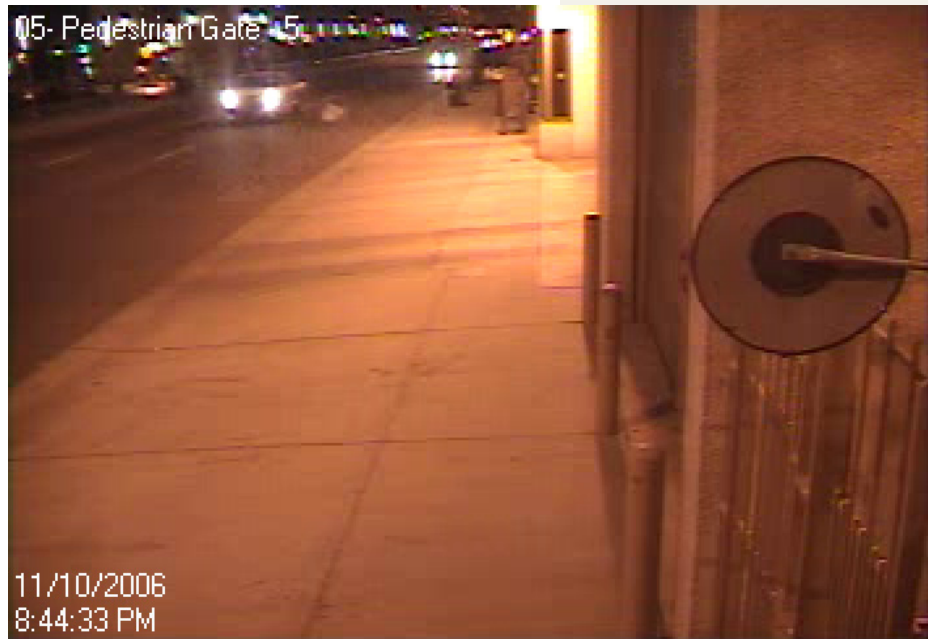
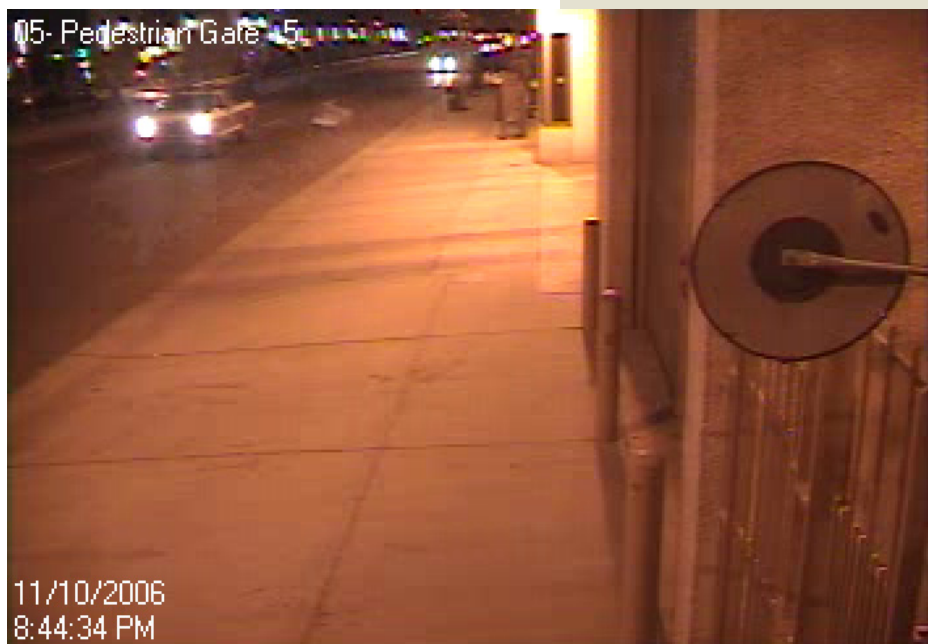
Figure 1 (top) and Figure 2 (bottom)

Figure 1 and Figure 2 are snapshots captured from Camera 5. The position of the truck in each of the snapshots was plotted on a scale diagram. The distance between each position could then be accurately measured using tools in the software. The travel distance for this segment was estimated to be 37 feet (11.28 meters). The time it took to travel that distance was 0.5 seconds. The formula to determine an average velocity over a known distance and time is $v = \text{distance} / \text{time}$. Therefore, $v = 37 \text{ feet} / 0.5 \text{ s} = 74 \text{ fps}$. 74 fps can then be converted to 50 mph. In metric units it would be $v = 11.28 \text{ m} / 0.5 \text{ s} = 22.56 \text{ mps}$ which can be converted to 81 kph. The posted speed limit for this roadway is 25 mph, or 40 kph.

two different cameras (focused in relatively the same area) investigators realized results that were within 1 mile per hour of each other. This analysis was completed at different locations along the truck's path with similar results. The video showed that the driver applied his brakes and also accelerated at different locations along his route.

The velocity estimates were, therefore, only applicable in the areas they were calculated and a note was added to the report to that effect.

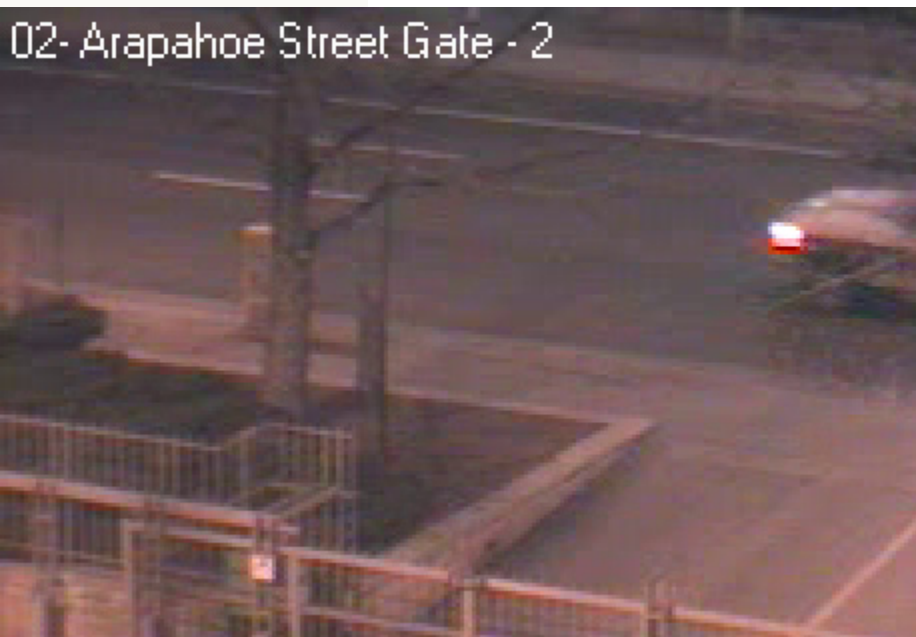
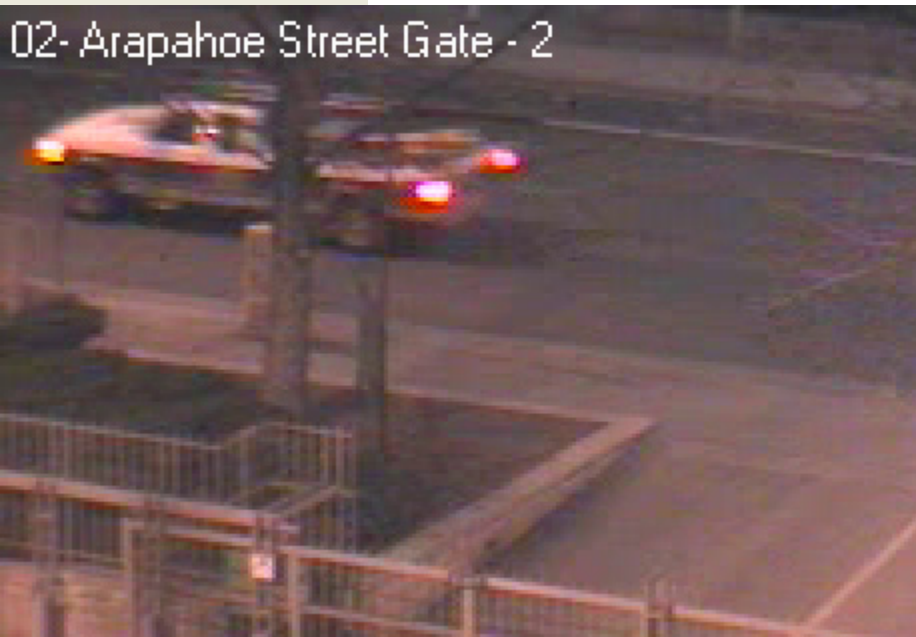
▲
Figure 3 (top) and Figure 4
(bottom)

Figure 3 and Figure 4 are snapshots captured from Camera 2. The travel distance was estimated to be 36 feet (10.97 meters) and the time it took to travel that distance was 0.5 seconds, $v = 36 \text{ feet} / 0.5 \text{ s} = 72 \text{ fps}$. 72 fps can then be converted to 49 mph. In metric units it would be $v = 10.97 \text{ m} / 0.5 \text{ s} = 21.94 \text{ mps}$ which can be converted to 78 kph.
